safetynet

Edition 31 | March 2021

SAFETY EVENTS

Selected events that occurred between January and December 2019

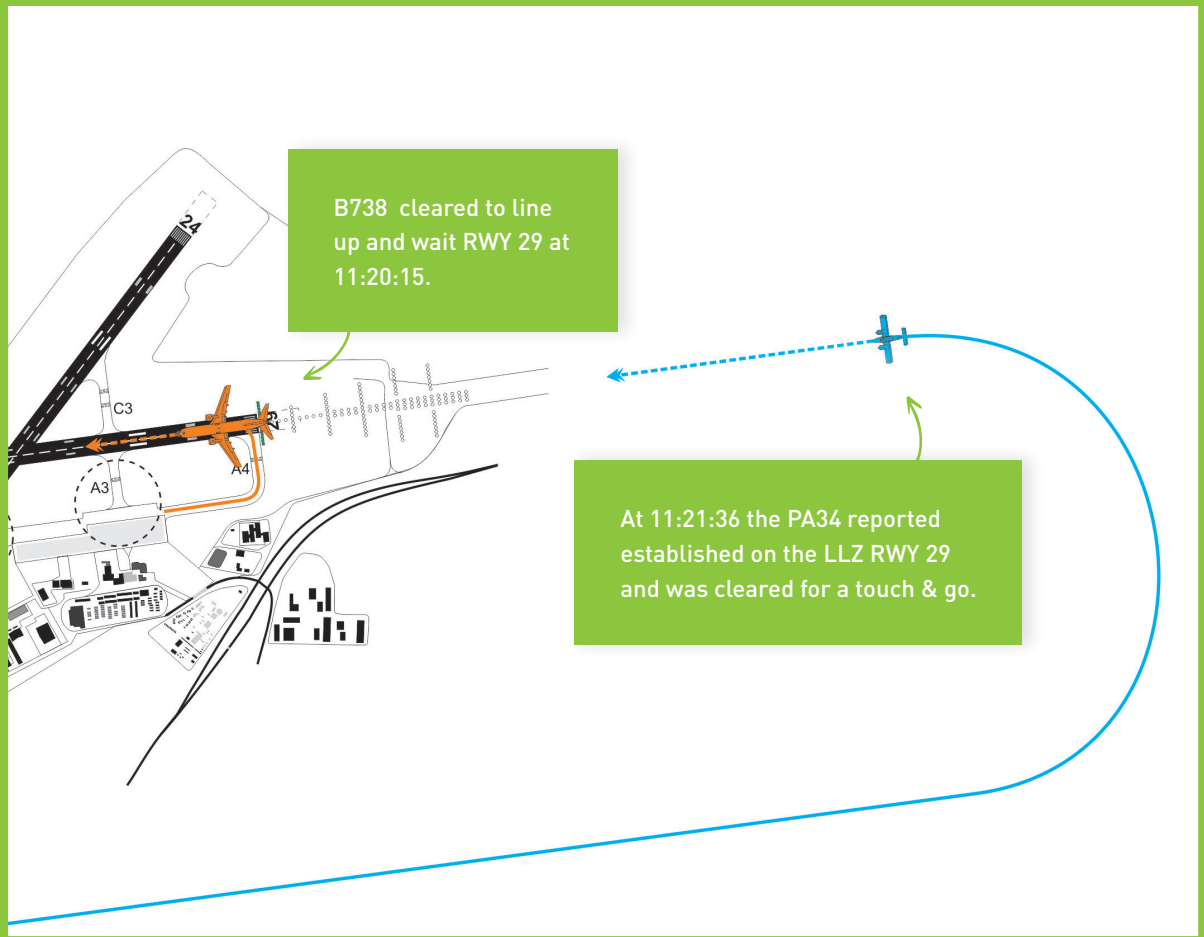
On **24th February 2019** a RI occurred on RWY29 at 11:21:36 UTC between a B738 and a PA34.

The following contributing factors were identified for this RI:

- a. The investigation concluded on negligence on the part of the controller in the form of a distraction caused by personal telephone call whilst on position. The event controller made a personal telephone conversation for approximately 12 minutes whilst on operational position. The event controller was engaged in a personal phone call on the VCCS when they cleared the B738 to line up and the PA34 to Touch and Go RWY29.

- b. There was incorrect flight progress strip management.
- c. Failure to scan RWY29 before issuing traffic on final approach with a landing clearance. The event controller appeared oblivious to the risk of conducting a personal call whilst on operational position. They did not recognise the emerging distractions when preceding landing aircraft was issued incorrect taxi instructions and the incorrect use of call-signs for a taxiing aircraft.

- d. The RI occurred within the first 22 minutes of the controller assuming control of the position, thereby being in a lowered mental alertness state still.

- e. The line-up clearance of the B738 was issued eighty-one seconds before the touch-go clearance was issued to the PA34. This causes the action and plan to exit the short-term memory that could not be recalled again at the time of the PA34 reporting on final approach. Such instructions have to be kept within the first 15 to 30 seconds to avoid such lapses unless prominent cognitive reminders can be initiated in the meantime.

Certain recommendations were drafted to assist in curbing similar risk situations from occurring again in the future. These are:

- i. Draft an ATS operational instruction that addresses operational distractions whilst on position, i.e. non-operational conversations with colleagues, personal telephone calls, use of devices for non-operational purposes etc.
- ii. Reinforce Mandatory Occurrence Reporting throughout the unit.
- iii. Reinforce runway occupancy vigilance and flight progress strip management throughout the unit.
- iv. Reinforce practice not to issue RWY-related clearances more than 20 seconds in advance so as to keep situation/risk in short-term memory.

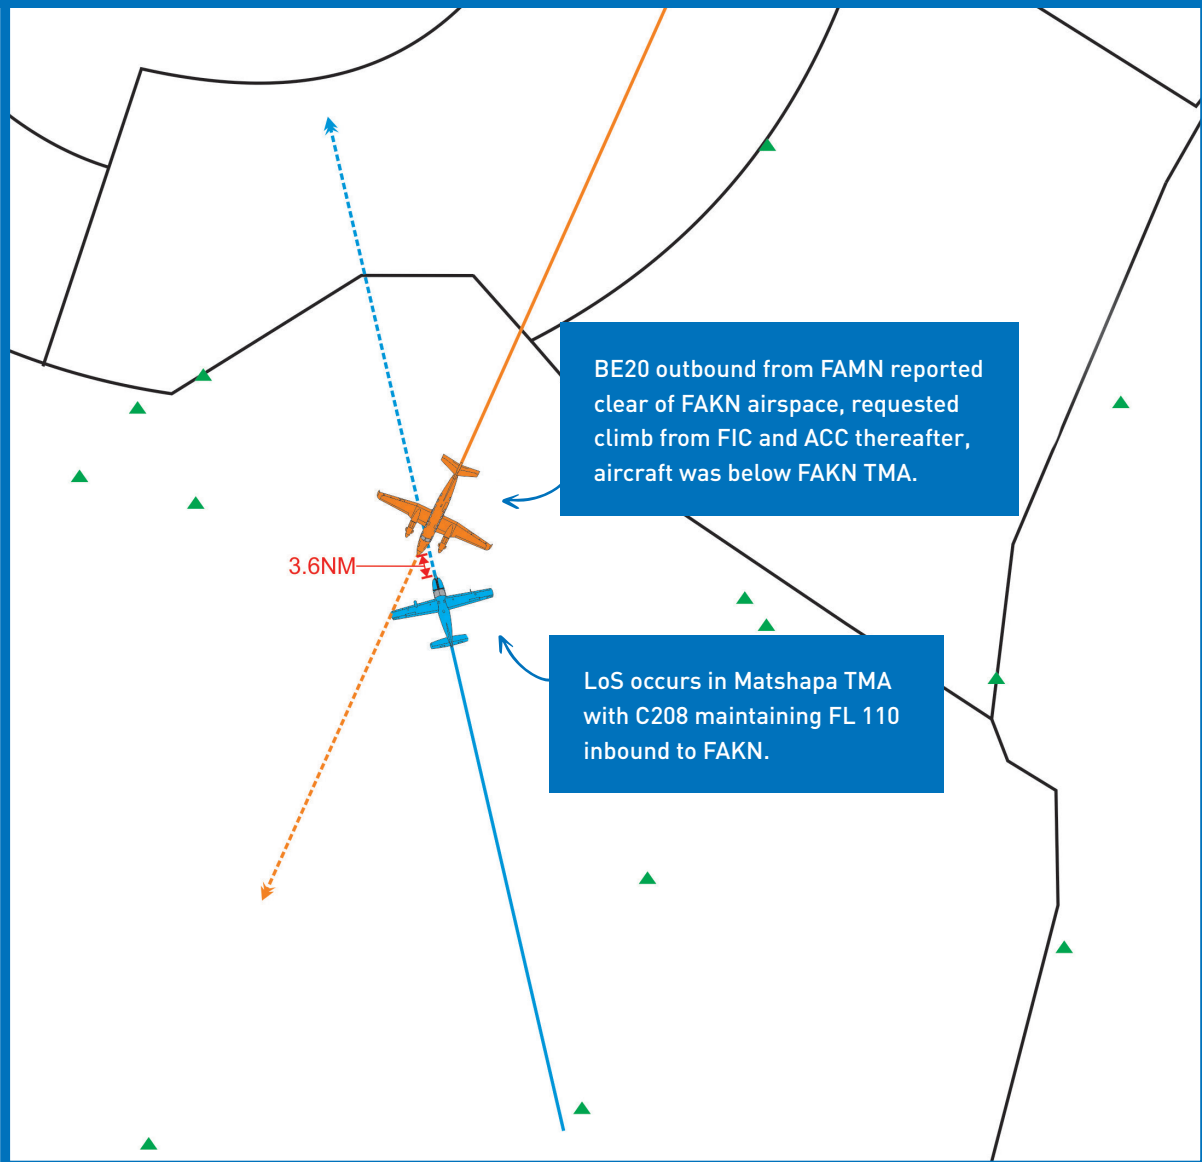
On **31st May 2019** an ATC operational error led to a LoS in the Sikhuphe TMA. This occurred at 11:48:37 UTC between a C208 and a BE20.

At 11:48:14 a LoS is observed in Sekhuphe airspace. The BE20 appeared on radar approximately 1NM inside Sikhuphe airspace maintaining FL105 while the C208 was at FL110.

Certain system-based recommendations were made to better prepare for the service to be provided and safety not to be compromised in similar future scenarios:

- i. Investigate the quality of the radar and communication capability of the sector – revisit previous recommendations and develop a list of mitigations that will be actioned – while providing progress updates to the Pool.
- ii. Review coordination practice of the FIC pool and the MSP and the associated training of such practices.
- iii. Engage the crew/operator of the BE20 to ensure they are familiar with the complex airspace design of the FAKN TMA.
- iv. As a minimum, ensure that the ATSU investigation reports are shared with the controllers involved.

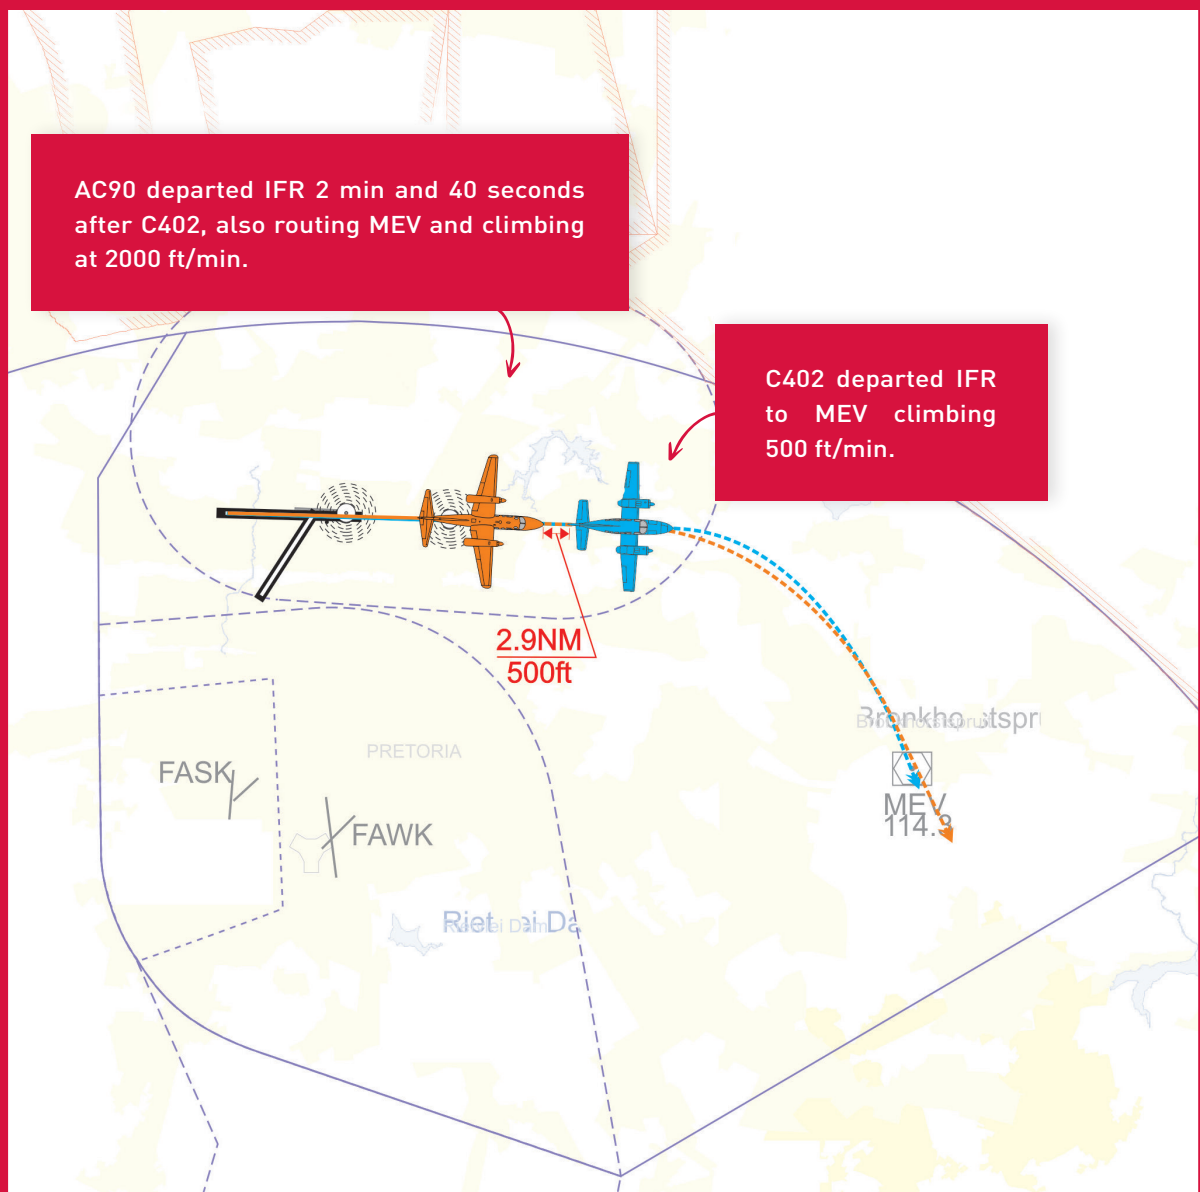
AC90 departed IFR 2 min and 40 seconds after C402, also routing MEV and climbing at 2000 ft/min.

C402 departed IFR to MEV climbing 500 ft/min.

- b. MEV is no longer listed as a VOR servicing FAWB. NOTAM A2691/20 has been issued stating the MEV is temporarily withdrawn. The use of the published GPS coordinates for an unserviceable beacon is common practise but a decommissioned beacon has no associated coordinates. During the investigation it was found that the NOTAM defining "Point MEV" had lapsed and as a result of the investigation was re-issued. The long-term solution to replacing MEV with a navigational aid or waypoint has not been concluded.

- d. It is not clear why the controller was working combined positions of GMC, Aerodrome and Procedural Approach at the time of the event. This is noted because the ATSU had 35 movements in that hour that seems quite high for a Procedural Approach unit and especially for a combined sector/service operation. One of the main goals of separated frequencies and positions are to enable service provision and safely deal with higher traffic demands.

- f. The controller was also not withdrawn from position following the LoS. It can only be assumed that the ATSU was dealing with a challenge of staff shortages at the time. Three months prior, two controllers filed fatigue reports due to only 4 people on the roster per day and working 5 hours non-stop before breaks are afforded (the recommended break time is after 2 to 2.5 hours for medium to high traffic demand or complex airspace ATSUs). The staff shortage was due to medical reasons, maternity leave, a pending validation and transfers.

Some recommendations were formulated to address the identified risks as depicted below:

- i. Confirm any current fatigue risks at FAWB.
- ii. Ensure that FAWB staff understands the fatigue triggers that should attract fatigue reports – even though it is the frequency of such occurrences that determines the level of risk and whether action should be taken.
- iii. Explore and capture the available means to deal with IFR separations within the FAWB airspace and identify the areas where means to separation is lacking.
- iv. It is further recommended that certain scenarios be created of IFR departures with local operating aircraft and the range of separation solutions available – to be used as a training/refreshers tool at FAWB.

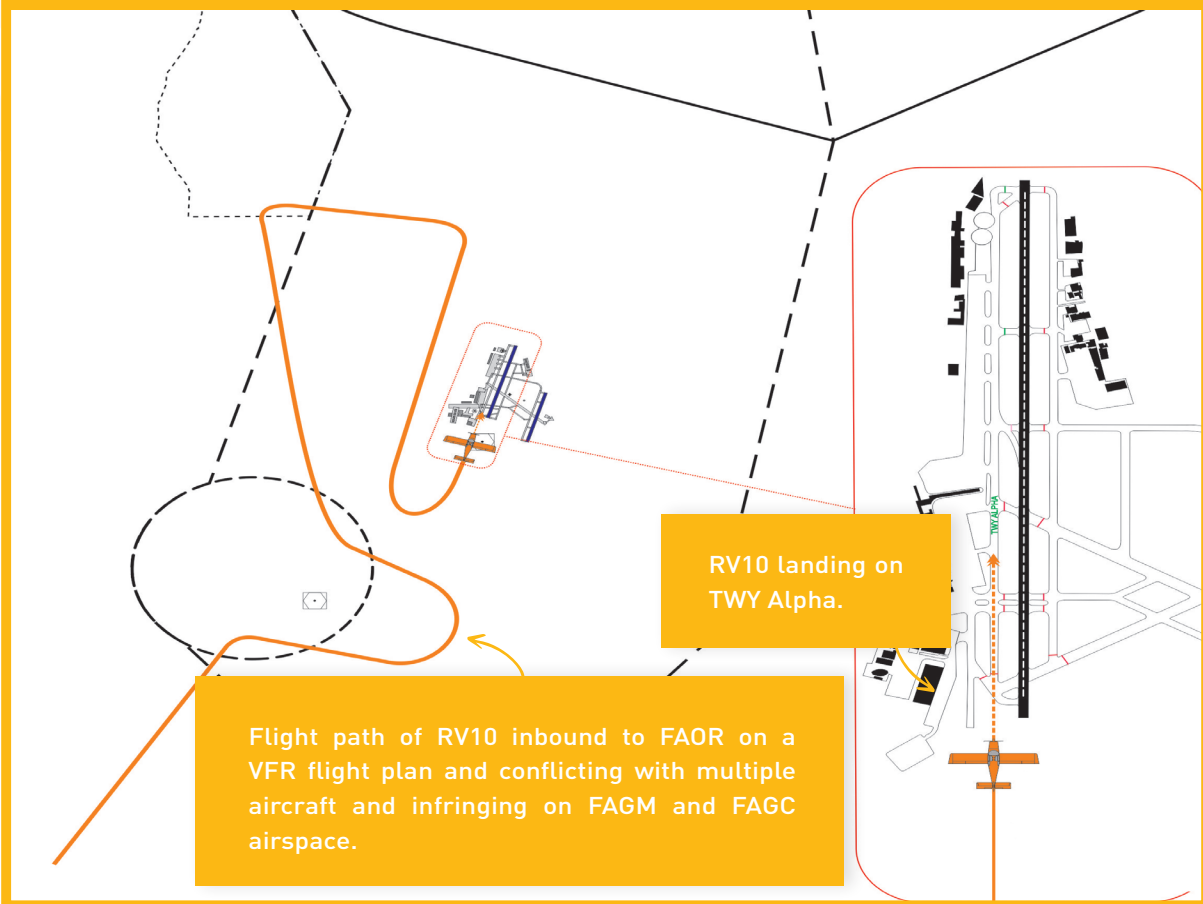
On **29 August 2019** a RV10 on a VFR flight from FATP to FAOR, entered the FAOR CTR from the South without a joining clearance, resulting in an AIRPROX with an E135 and subsequent re-positioning of second E135 and a RJ85.

The RV10 continued to infringe upon the FAGM and FAGC ATZ's and was re-positioned for RWY03L but landed on TWY Alpha, parallel to the Runway, with several aircraft holding at TWY's India and Lima. Several sectors

- h. No alerts were activated due to the aircraft operating in the STCA inhibition zone.
- i. Systemically there were a few factors that contributed to the unfolding traffic scenario. The first being the management of flight plans. In the end due to airport related matters, the aircraft repositioned a second time to FATP and this caused the system to contain more than one flight plan that added to a certain level of confusion.

As a result, these recommendations were made to prevent similar occurrences occurring in the future:

- xii. Training to be provided to the FIS ATSO on process/actions to follow when traffic is routing VFR inbound to FAOR. This training can also be extended to the FIC Pool as it has been identified as training deficiency.

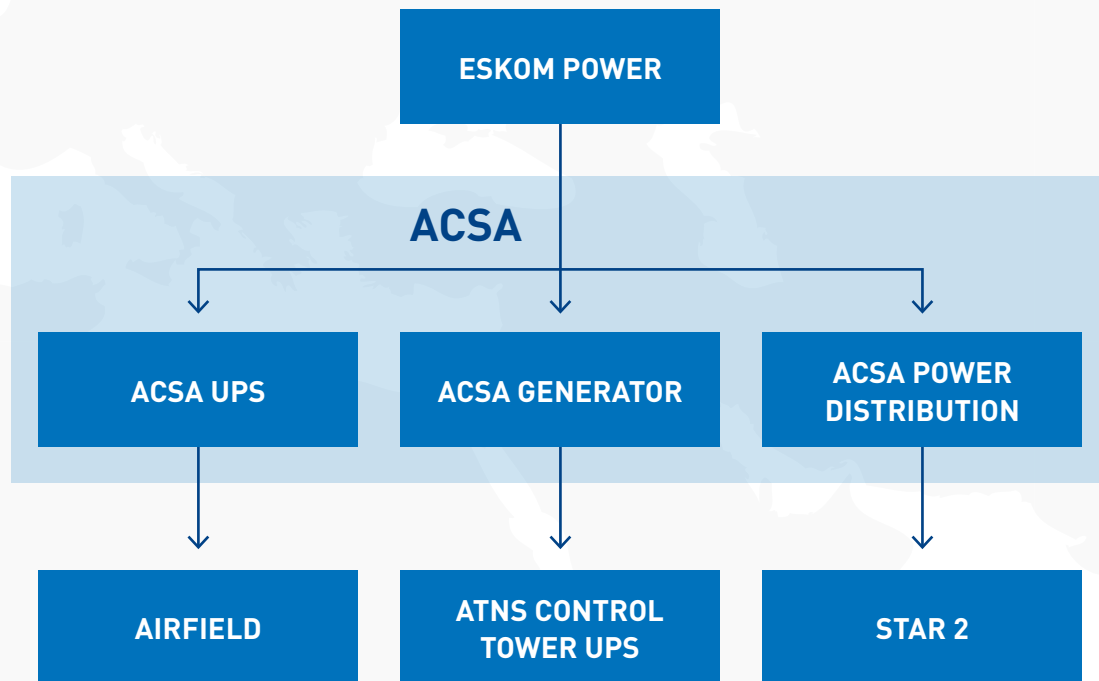
Diagram: ATNS power link connection to ACSA's generator.

At 00:30 local time, the ATC reported a power failure at the control centre; this was the exact time ACSA Electricians were busy with power tests. As a result, the FACT control Tower, the entire airfield, and Star 2 area lost power supply, and all three section's back-up power did not activate.

When the electrical power was restored, an investigation by FACT ATSEPs found that there was significant (ABOUT 90 Volts) potential difference between the electrical ground wire and the neutral wire. Under normal circumstances, these two legs should have a potential difference of 0 Volts. The potential difference of 90 Volts is suspected, that it might have prevented the UPS/Generators from taking over the load.

The following recommendations were produced as a result of the various investigations:

- i. It was recommended that the Neutral and Earth bar in the Low Voltage Distribution Cabinet at the FACT centre be strapped together by an authorised electrician.

- ii. The strapping of the Neutral and Earth will prevent any floating voltages in future, which will eliminate the potential for any UPS and/or generator to not carry the load during power failures.

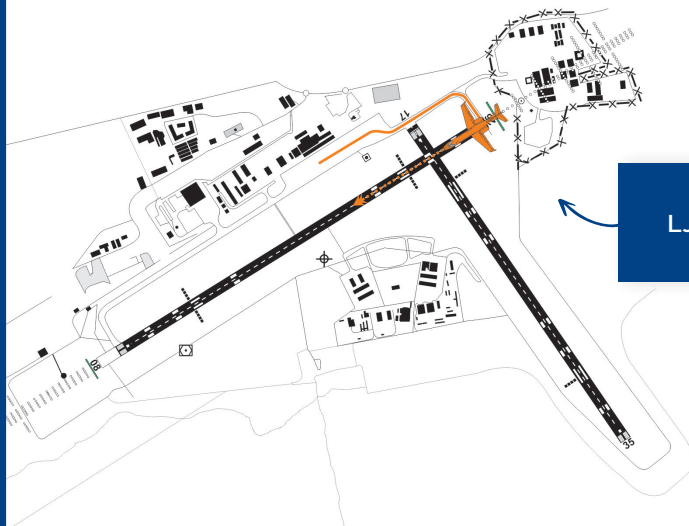
On **21st November 2019** a Runway Incursion occurred at 12:40:59 UTC between a LJ45 and a B734.

B734 on long final approach RWY 26 and cleared to land 2 min and 25 seconds after line up clearance was issued to the LJ45.

LJ45 lined up RWY 26.

- a. It appears that the pressure that training is placing on the operational system is adding an additional risk that is not mitigated at present. In this particular setting, the controller was exposed to 2 hours on position only. In addition, the controller's previous time on the particular position was 10 days prior. In other words, skill maintenance becomes a topic of concern. This is especially relevant as this investigation found that the previous two safety events at this ATSU also had two ATCO3 controllers involved that were not working aerodrome control as their primary service and skill set. This was also evident in the comment by the controller that the RWY was only scanned after the landing clearance was issued to the B734 – indicating a potential memory lapse that can be rectified through repetition priming (more frequent exposure to re-establish the skill set and correct sequence of actions required). However, the scanning technique applied should be explored further. It is not clear whether this was a simple single occurrence or perhaps a habit that has developed over time from the individual or perhaps even the team. A monitoring programme may be able to assist in determining the nature and extent of the incorrect scanning that occurred on the day. Should this not be a once off occurrence, further time has to be invested in training the individual or team in an adjusted scanning technique.

The following recommendations were concluded on during the investigation:

- ii. Review rosters over a period of 3 months to determine whether the frequency of rostering ATCO3s are creating the potential for a skill degradation risk (including time per day and number of shifts on this position).
